## no. 07

3-bedroom villa, Lamai

03, foundations and  
ground beams

Week 13, morning

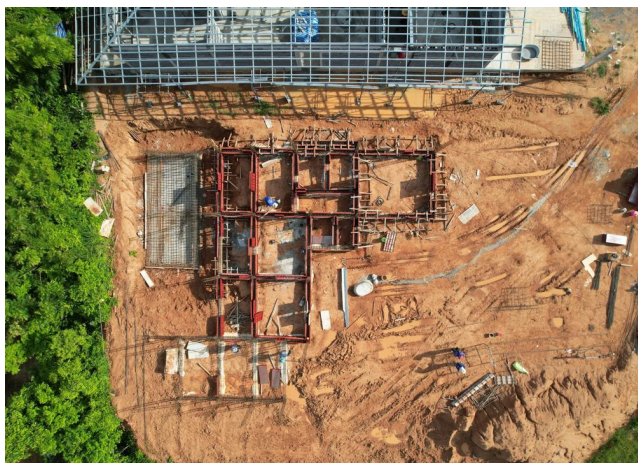
| NO. | ITEM CHECKED | FINDING | STATUS |
|---|---|---|---|
| 01 | Footing positions | Measured on six footings, matching the foundation drawing. | ● Compliant |

PHOTO 1  
Overhead view, foundation layout

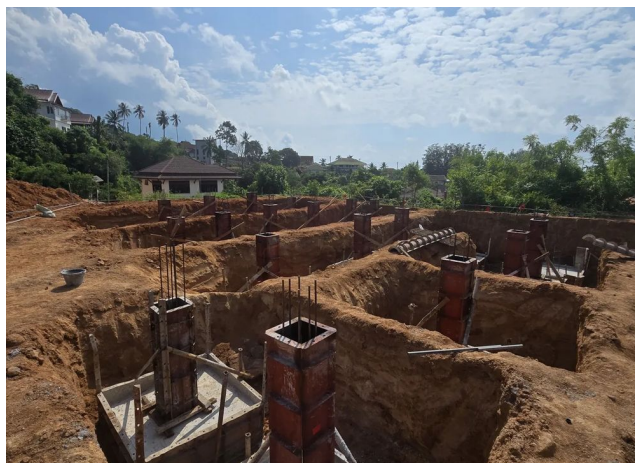
| NO. | ITEM CHECKED | FINDING | STATUS |
|---|---|---|---|
| 03 | Column starter rebar | Bar sizes and link spacing as drawn. | ● Compliant |

PHOTO 2  
Footings poured and column starters

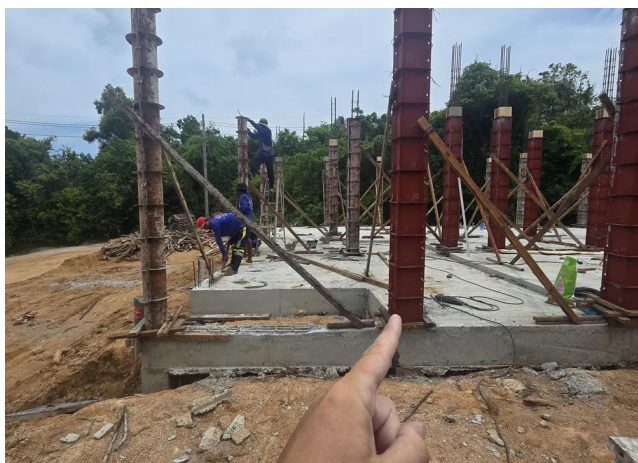
| NO. | ITEM CHECKED | FINDING | STATUS |
|---|---|---|---|
| 04 | Concrete cover, axis C | Not enough spacers on two columns. Corrected during the visit, see photo 3. | ● Issue cleared |

PHOTO 3  
Axis C columns after the spacers were corrected

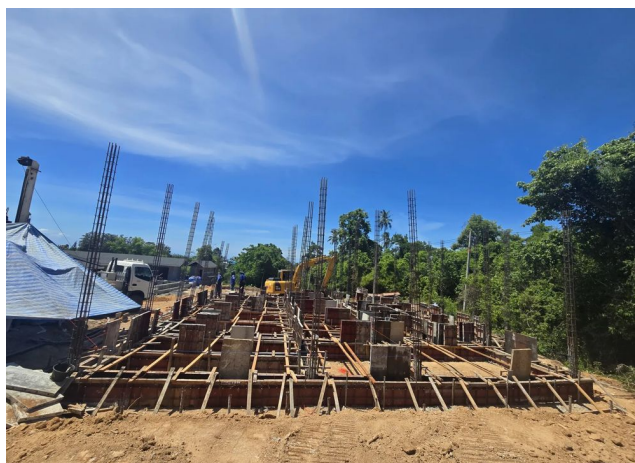
| NO. | ITEM CHECKED | FINDING | STATUS |
|---|---|---|---|
| 05 | Ground beam formwork | Line and levels checked with string line and laser level. | ● Compliant |

PHOTO 4  
Ground beam formwork before the pour
